**A Prescription Outline for Watershed
Restoration, Saxon Creek Sub-basin,
Quadra Island
April, 2010**

March 28, 2010

**Prepared by: L.M. Bowles, RPBio.
Box 22, Heriot Bay, BC
V0P 1H0
todspnd@gicable.com**

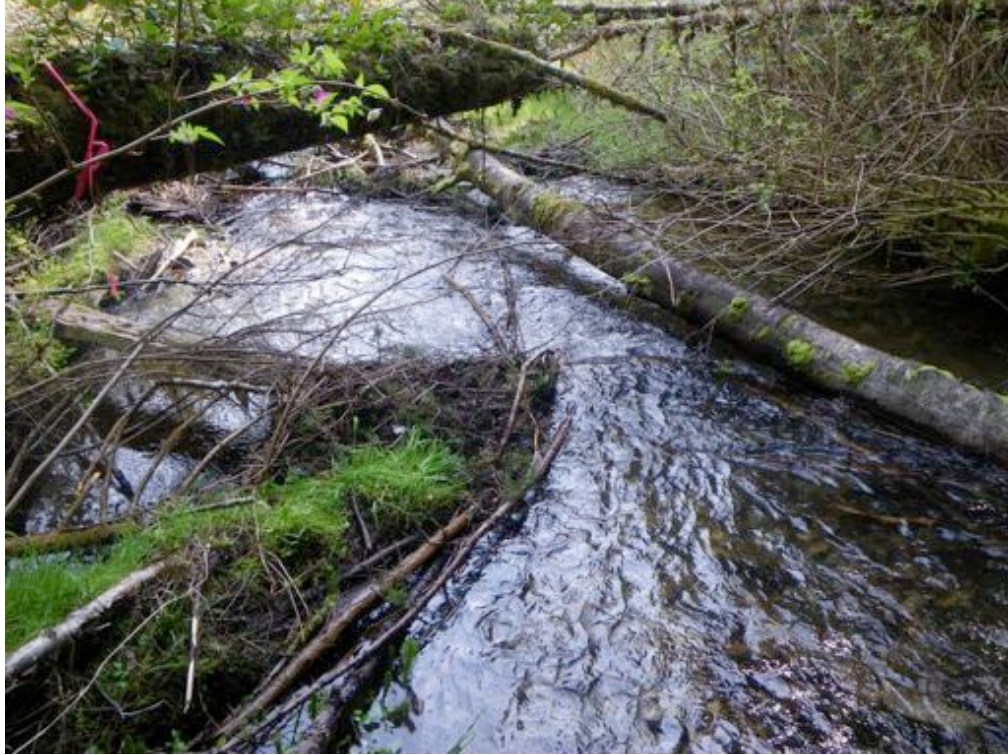
Site 1. 0+42m

Site 1. The overhanging cedar log is to be cut, dropped and pinned into the creek bed to create a sill log.

- An existing wind thrown cedar log laying across but above the creek is to be fallen into the creek in order to create a sill log. The goal will be to create downstream ponding.
- Existing wood will be first relocated from site. Each end will then be fitted into the shoreline to ensure stream flow does not erode around the log. To pin the log in place double 1 m long ½ inch rebar will be drilled through each end of the log and, in turn, driven into the creek bed.

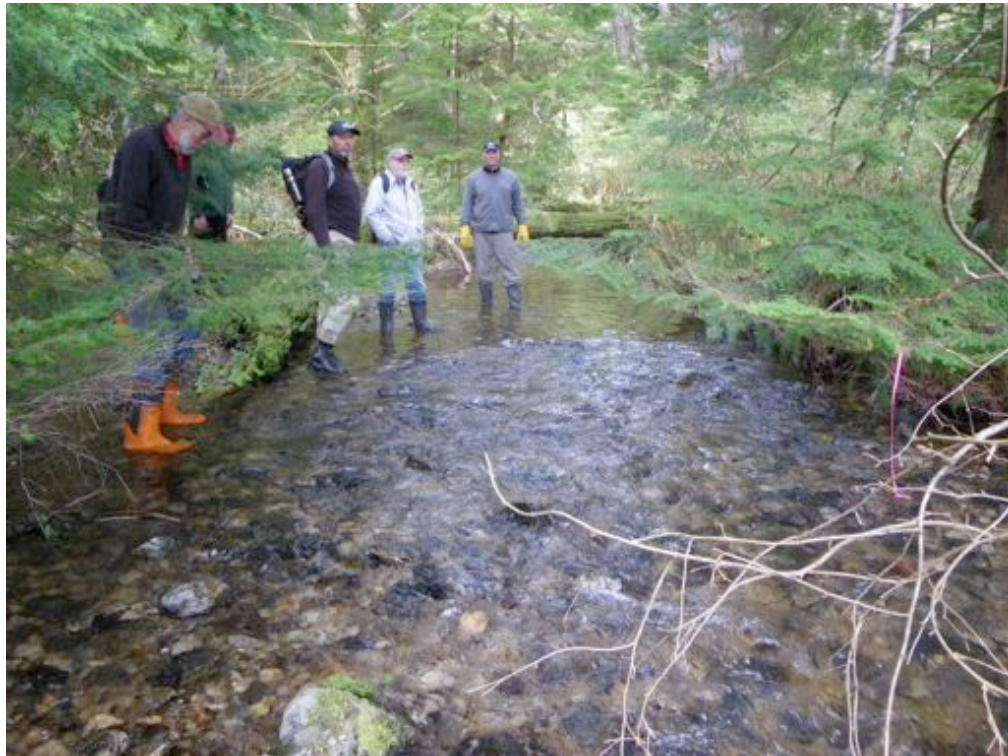
Site 2. 0+52m

Site 2. – Site for a two log deflector installation. Each deflector extending $\frac{2}{3}$ distance into stream bed, spaced 2 m apart.

- Two pieces of existing wind fallen riparian fir are to be placed into the creek. One piece will be placed into the creek from the east shoreline, the other 2 m downstream from the westerly shoreline, creating two deflector logs with object of creating scour holes in the creek and, as well to act as debris catchers.
- Each log will be anchored by 5/16 in. galv. cable to stream side trees with the instream end of the logs anchored with epoxyed cable and rocks.

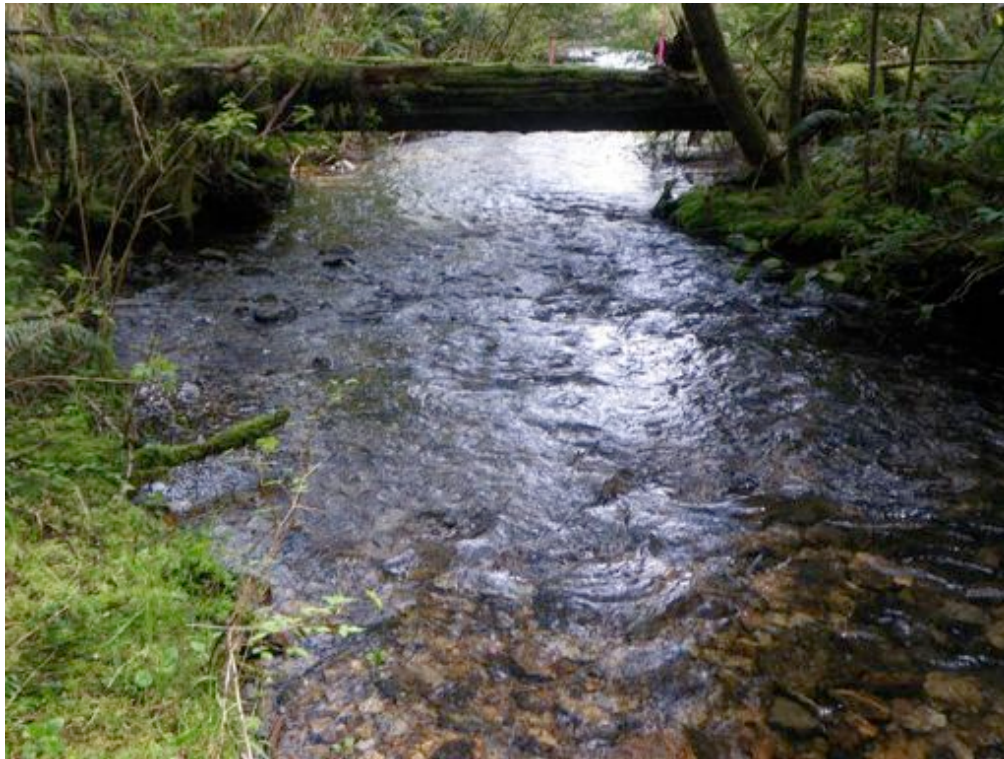
Site 3. 0+ 62m

Site 3. – Cedar cross log to be cut, dropped into creek and pinned with rebar to create a sill log.

- An existing windthrown cedar log laying across but above the creek is to be fallen into the creek and anchored into place in order to create a pool-forming sill log. Each end of the log will be anchored using two 1 m long ½ inch rebar driven into the creek bed.

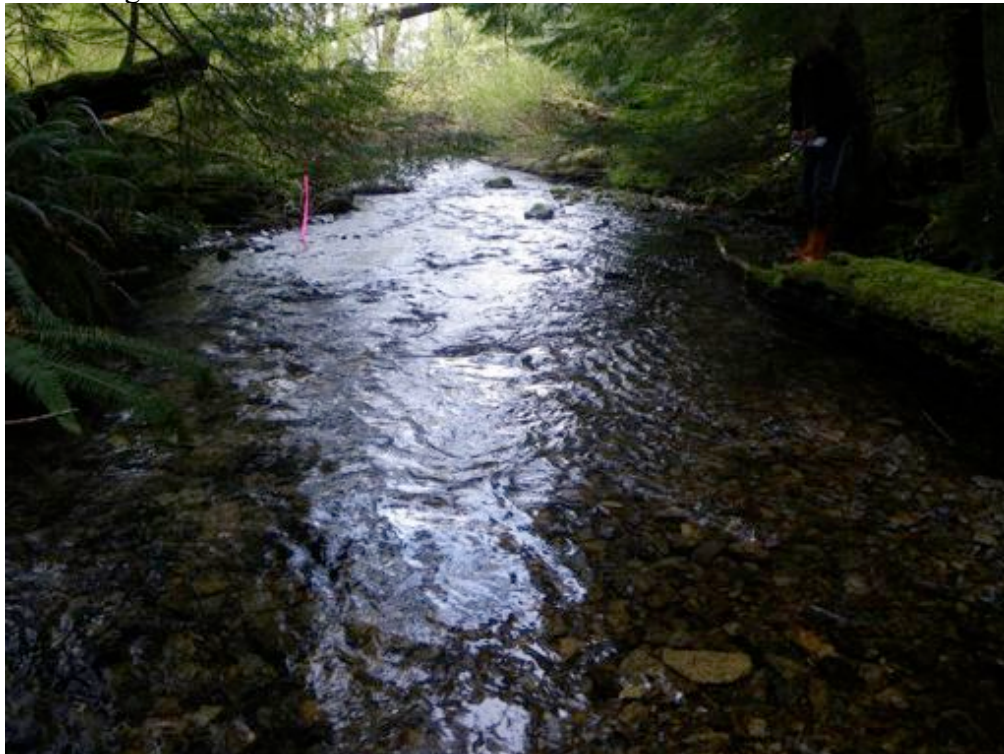
Site 4. 0+ 70 m

Site 4. – A deflector log is to be installed into the creek (east side) and will extend 2/3 across the creek. The log is to be anchored using 5/16 galv. cable to a stream

side hemlock.

- A deflector log is to be installed into the creek (east side) to extend 2/3 across the creek. The log is to be anchored using 5/16 galv. cable to a stream side hemlock and epoxed to ballast rocks as required. Existing fir windfall is available adjacent to the stream.

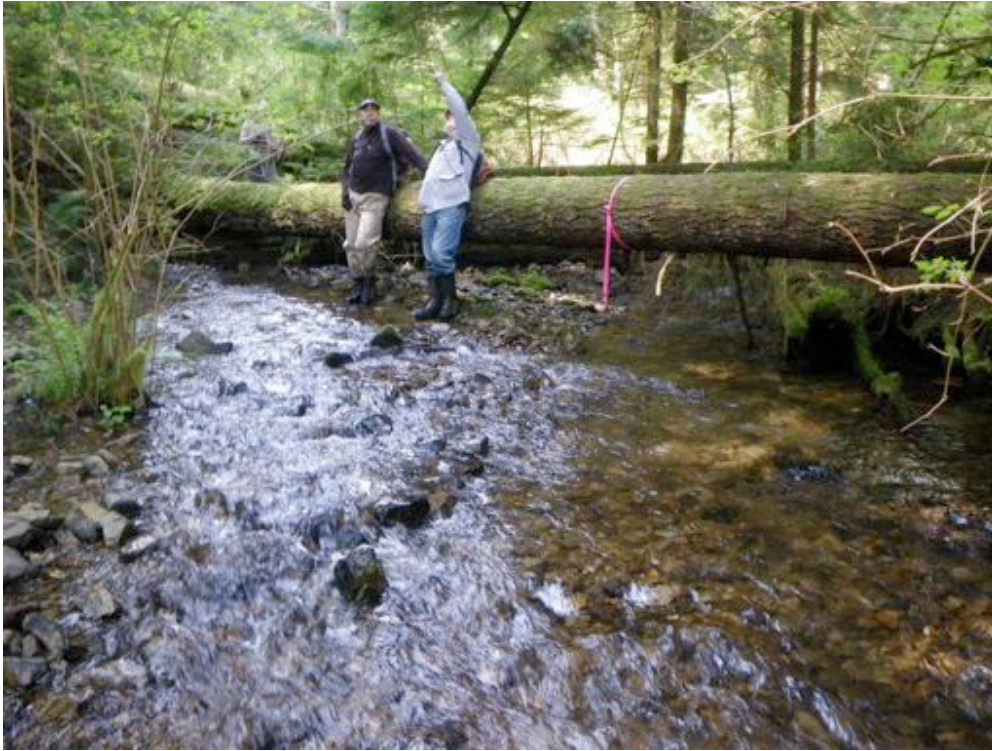
Site 5. 0+ 79m

Site 5. – Large fir log is to be cut at approximately the ribbon point and allowed to fall into the stream. The root wad (hidden to the left) will anchor the log.

- An existing wind fallen large fir cross log extends across but above the river. The downstream end of the log is to be cut to permit the log to fall in to the stream such that the log extends 2/3 across the stream bed. The large root wad will act as the anchor for the log.

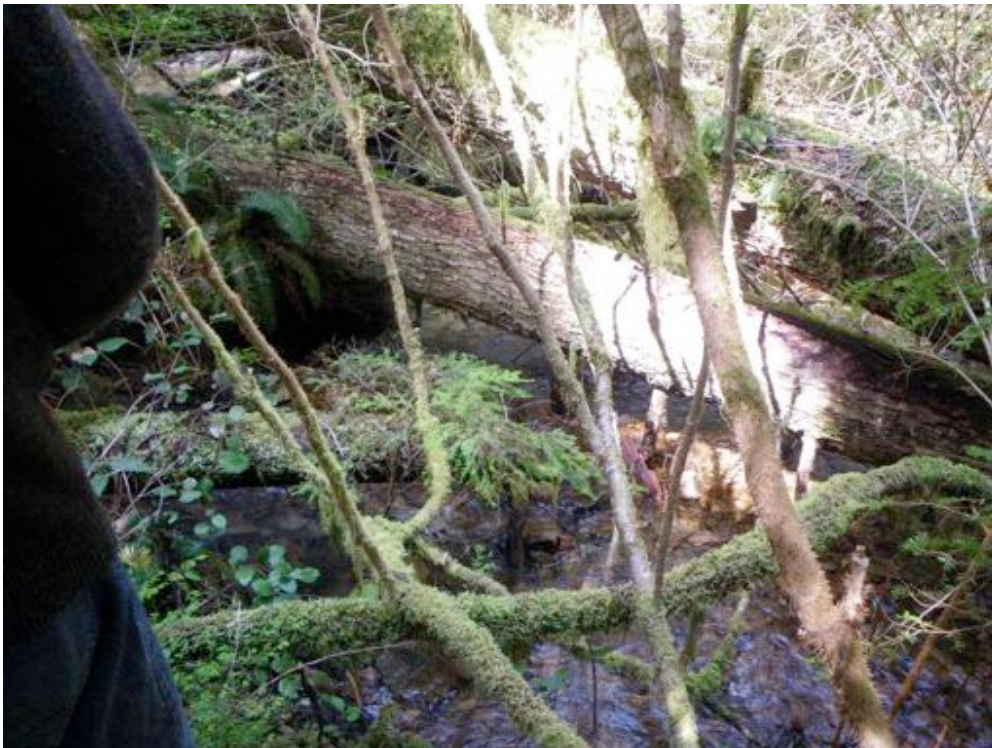
Sites 6, 7 and 8. 0+85m to 0+ 160m

Sites 6, 7 and 8. – In an area of extensive wind fall several wind thrown logs which overhang the creek, are to be fallen into the stream to crate deflectors and debris

catchers.

- This is a zone of wind thrown fir and hemlock from the upper east side of the riparian (the result of wind exposure from an eight year old cut block above the eastern riparian zone). The trees span the creek from bank to bank. 3-4 of the trees are to be cut such that one end falls into the creek. The remainder of the tree will be of sufficient mass to anchor the instream portion of the log. The trunks will be staggered between the east and west banks in order to twist the thalweg through the stream bed.

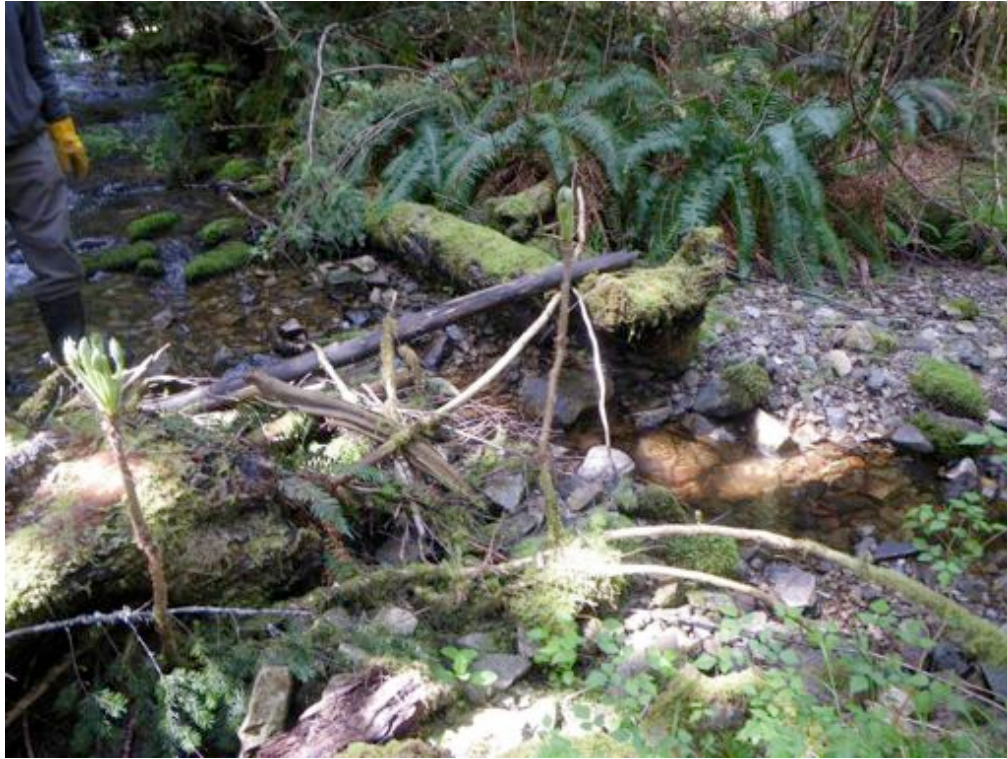
Site 9. 0+228m

Site 9. – Blocked entrance to the westerly side channel. Stream is to the left. Rock is to be removed from the inlet and used to construct a deflector berm slightly upstream. The berm should cause a back eddy in the channel mouth and remove bar gravel from accumulating in the future.

- The entrance to the side channel that is partially blocked by coarse gravel accumulations. Gravels are to be removed to allow greater flow in to the side channel. A deflector rock weir will be installed slightly upstream of the site to deflect the thalweg in such a manner that the entrance area becomes a scour area, rather than a deposition area thus keeping the entrance free of future gravel accumulation.
